Tree Inventory Plan
Water Street
Warren, Rhode Island
Client: **Town of Warren**
514 Main Street
Warren, Rhode Island 02885
DE Job No. 1645-002 Copyright 2012 by DiPrete Engineering Associates, Inc.

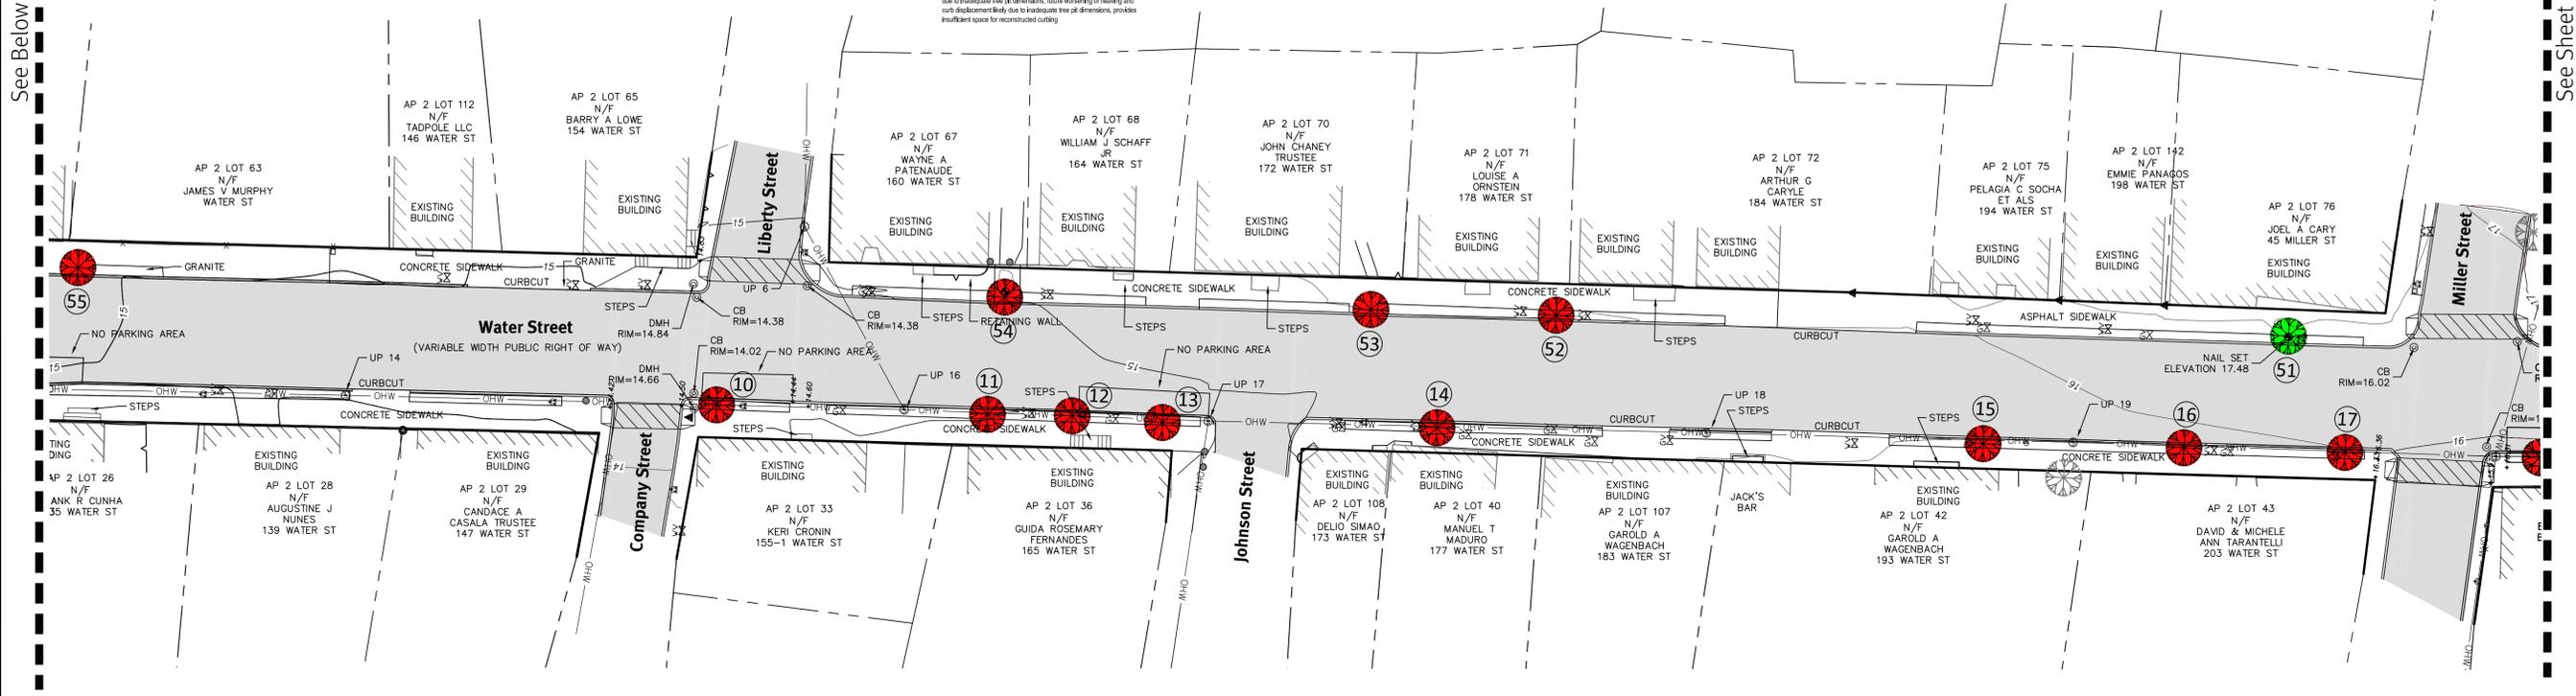
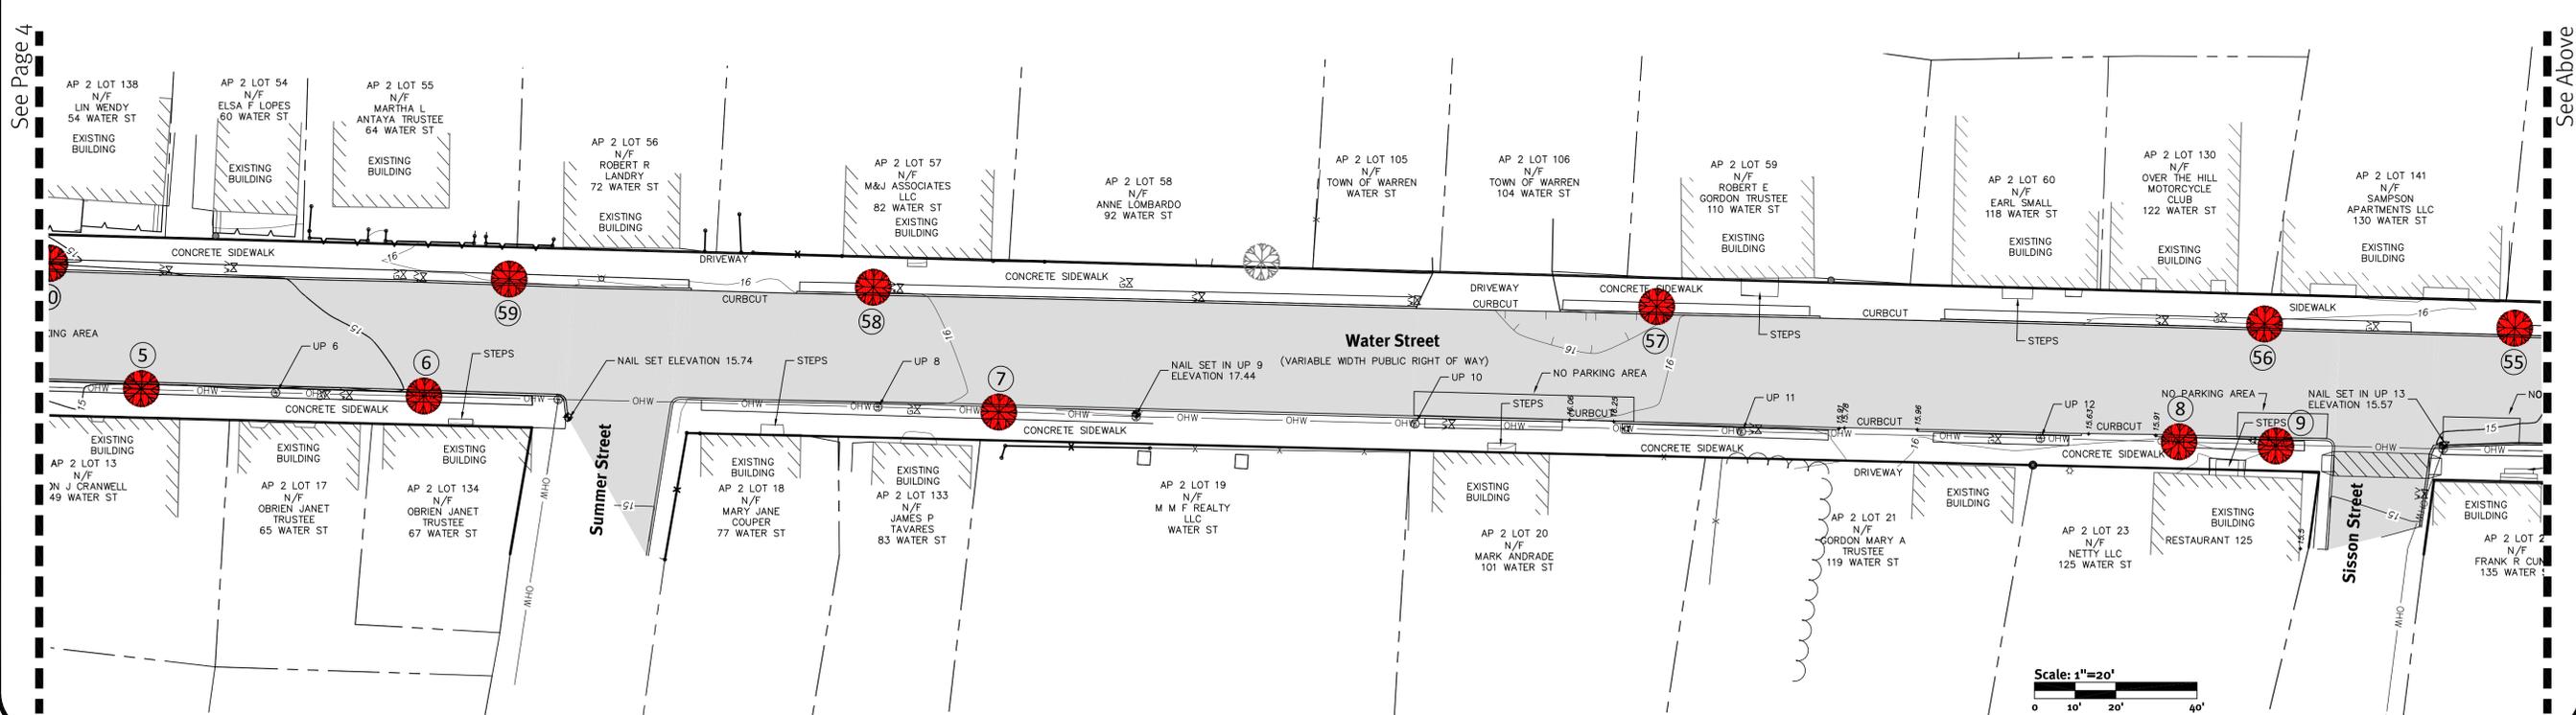
Tree No.	Species	Trunk Caliper	Existing and Potential Root Growth Conflicts	Overall Tree Health and Conditions
5	Honey Locust	16"	Major - minor upheaval of sidewalk, exposed roots, curb displaced, future worsening of heating and curb displacement likely due to inadequate tree pit dimensions, provides insufficient space for reconstructed curbing, provides insufficient space for reconstructed sidewalk or curbing.	Poor - branching conflicts with building and overhead wires, center of tree cut to accommodate overhead wires, large section bearing [growing over roadway posing safety hazard, tree is too large for area.
6	Norway Maple	15"	Minor - minor upheaval of sidewalk, exposed roots, future worsening of heating and curb displacement likely due to inadequate tree pit dimensions.	Fair - branching conflicts with building and overhead wires, some central branches cut to accommodate overhead wires, section bearing [growing over roadway posing safety hazard, tree is too large for area.

7	Amur Cork Tree	17"	Moderate - moderate upheaval of sidewalk, exposed roots, future worsening of heating and curb displacement likely due to inadequate tree pit dimensions.	Fair - branching conflicts with building and overhead wires, health of tree appears to be declining, heavily pruned limbs, some central branches cut to accommodate overhead wires, tree is too large for area.
8	Bradford Callery Pear	20"	Moderate - moderate upheaval of sidewalk, exposed roots, curb displaced, future worsening of heating and curb displacement likely due to inadequate tree pit dimensions, provides insufficient space for reconstructed curbing, provides insufficient space for reconstructed sidewalk or curbing.	Poor - branching conflicts with overhead wires, heavily pruned limbs on west side, some central branches cut to accommodate overhead wires, large section bearing [growing over roadway posing significant safety hazard, large trunk cavity on main leader from prior limb breakage, species is known for weak limb unions creating higher likelihood of limb breakage or structural failure, tree is too large for area.

9	Bradford Callery Pear	9"	None - future heating and curb displacement likely due to inadequate tree pit dimensions.	Fair - branching conflicts with overhead wires, tree is leaning [growing toward roadway posing future safety risk, some lower trunk damage observed, species is known for weak limb unions creating higher likelihood of limb breakage or structural failure.
10	Green Ash	21"	Moderate - moderate upheaval of sidewalk, exposed roots, curb displaced, future worsening of heating and curb displacement likely due to inadequate tree pit dimensions, provides insufficient space for reconstructed sidewalk or curbing.	Poor - branching conflicts with building and overhead wires, heavily pruned limbs on west side, central branches cut to accommodate overhead wires, tree is leaning [growing over roadway posing significant safety hazard, tree is too large for area.
11	Kwanzaan Cherry	7"	None - future heating and curb displacement likely due to inadequate tree pit dimensions.	Poor - branching will soon conflict with building and overhead wires, remaining section of tree is leaning [growing toward building, entire east side of tree has been removed, health of tree appears to be declining, dead branches observed.

12	Kwanzaan Cherry	9"	Minor - minor upheaval of sidewalk, future worsening of heating and curb displacement likely due to inadequate tree pit dimensions.	Poor - branching conflicts with building and overhead wires, health of tree appears to be declining, branch structure is targeted, trunk damage observed.
13	Kwanzaan Cherry	8"	Moderate - graded roots, future heating and curb displacement likely due to inadequate tree pit dimensions.	Poor - will soon conflict with overhead wires, health of tree appears to be declining, branch structure is targeted, heavily pruned to reduce conflicts, trunk damage observed.

Tree No.	Species	Trunk Caliper	Existing and Potential Root Growth Conflicts	Overall Tree Health and Conditions
14	Amur Cork Tree	17"	Moderate - moderate upheaval of sidewalk, exposed roots, curb displaced, future worsening of heating and curb displacement likely due to inadequate tree pit dimensions, provides insufficient space for reconstructed curbing, provides insufficient space for reconstructed sidewalk or curbing.	Poor - branching conflicts with overhead wires, heavily pruned limbs on west side, some central branches cut to accommodate overhead wires, large section bearing [growing over roadway posing significant safety hazard, tree is too large for area.
15	Kwanzaan Cherry	7"	None - future heating and curb displacement likely due to inadequate tree pit dimensions.	Fair - branching will soon conflict with building and overhead wires, health of some branches appears to be declining.
16	Red Maple	9"	Moderate - minor upheaval of sidewalk, exposed roots, curb displaced, future worsening of heating and curb displacement likely due to inadequate tree pit dimensions, provides insufficient space for reconstructed sidewalk or curbing.	Fair - branching conflicts with overhead wires, some central branches cut to accommodate overhead wires.

17	Norway Maple	12"	Minor - minor upheaval of sidewalk, future worsening of heating and curb displacement likely due to inadequate tree pit dimensions, provides insufficient space for reconstructed sidewalk or curbing.	Poor - branching conflicts with building and overhead wires, health of tree is declining, heavily pruned limbs on east side, tree is leaning [growing over roadway posing significant safety hazard, dead branches observed, old trunk damage observed, tree is too large for area.
51	Crisson King Norway Maple	4"	None - future heating and curb displacement likely due to inadequate tree pit dimensions.	Good [Fair - branching will conflict with building in the future, branching conflicts with overhead wires, minor trunk damage observed.
52	Norway Maple	16"	Major - major upheaval of sidewalk, exposed roots, curb displaced, future worsening of heating and curb displacement likely due to inadequate tree pit dimensions, provides insufficient space for reconstructed curbing.	Poor - branching conflicts with building and overhead wires, health of tree is declining, heavily pruned limbs on east side, tree is leaning [growing over roadway posing significant safety hazard, dead branches observed, old trunk damage observed, tree is too large for area.

53	Norway Maple	13"	Major - major upheaval of sidewalk, exposed roots, curb displaced, future worsening of heating and curb displacement likely due to inadequate tree pit dimensions, provides insufficient space for reconstructed curbing.	Poor - branching conflicts with building and overhead wires, health of tree is declining, heavily pruned limbs on east side, tree is leaning [growing over roadway posing significant safety hazard, dead branches observed, old trunk damage observed, tree is too large for area.
54	Green Ash	20"	Major - major upheaval of sidewalk, encroachment into roadway, sidewalk removal performed, exposed roots, curb displaced, future worsening of heating and curb displacement likely due to inadequate tree pit dimensions, provides insufficient space for reconstructed curbing.	Poor - branching conflicts with building and overhead wires, health of tree is declining, heavily pruned limbs on east side, tree is leaning [growing over roadway posing significant safety hazard, dead branches observed, old trunk damage observed, tree is too large for area.

55	Norway Maple	9"	None - future heating and curb displacement likely due to inadequate tree pit dimensions.	Poor - branching conflicts with building and overhead wires, health of tree is declining and tree is mostly dead, dead tree branches observed, trunk splitting observed.
56	Honey Locust	17"	Moderate - minor upheaval of sidewalk, exposed roots, curb displaced, future worsening of heating and curb displacement likely due to inadequate tree pit dimensions, provides insufficient space for reconstructed curbing.	Fair - branching conflicts with building and overhead wires, some decline in health and dead branches observed.

Tree No.	Species	Trunk Caliper	Existing and Potential Root Growth Conflicts	Overall Tree Health and Conditions
57	Norway Maple	22"	Moderate - moderate upheaval of sidewalk, exposed roots, curb displaced, future worsening of heating and curb displacement likely due to inadequate tree pit dimensions, future worsening of heating and curb displacement likely due to inadequate tree pit dimensions, provides insufficient space for reconstructed curbing.	Fair - branching conflicts with building and overhead wires, large section bearing [growing over roadway posing safety hazard, trunk damage observed on main leader.
58	Linden	17"	None - future heating and curb displacement likely due to inadequate tree pit dimensions.	Good [Fair - branching conflicts with building and overhead wires, some stem-damaged branches observed, tree is too large for area.
59	Linden	16"	None - future heating and curb displacement likely due to inadequate tree pit dimensions.	Good [Fair - branching conflicts with building and overhead wires, tree is slightly leaning over street, some stem-damaged branches observed, tree is too large for area.
